# **International Space Station EVA Wipe**

## **An extraordinary sample from a far-out place**

Philip M. Howard  
NASA  
Kennedy Space Center  
Materials Science Division

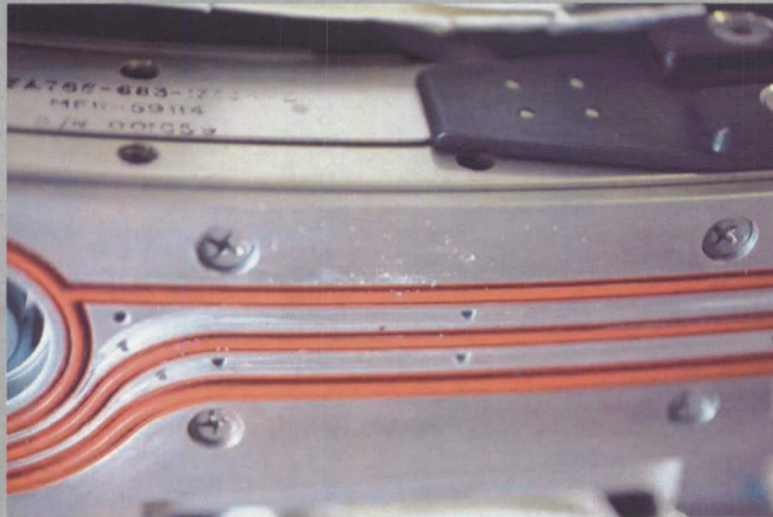
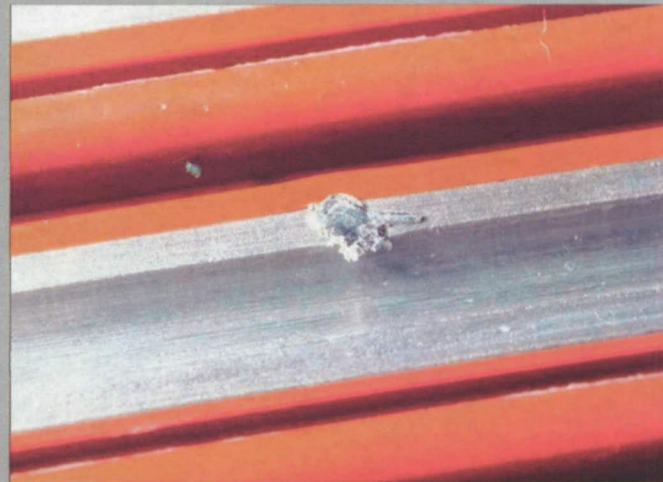
## *MPLM Seals from STS-114*

- Debris on the sealing surface raises concern of seal failure or damage. The seals are redundant for this reason. Estimated point of contact of the sealing surface, 1.5 mm.
- The fluorinated lubricant Braycote<sup>®</sup> 601 makes for an efficient collector of debris.
- Mylar covers were developed for the MPLM seal during processing and removed before flight. A permanent flight cover was deemed not feasible to remove while on orbit.
- Due to the vertical orientation and location of the MPLM seal in the cargo bay, debris can be deposited at launch.

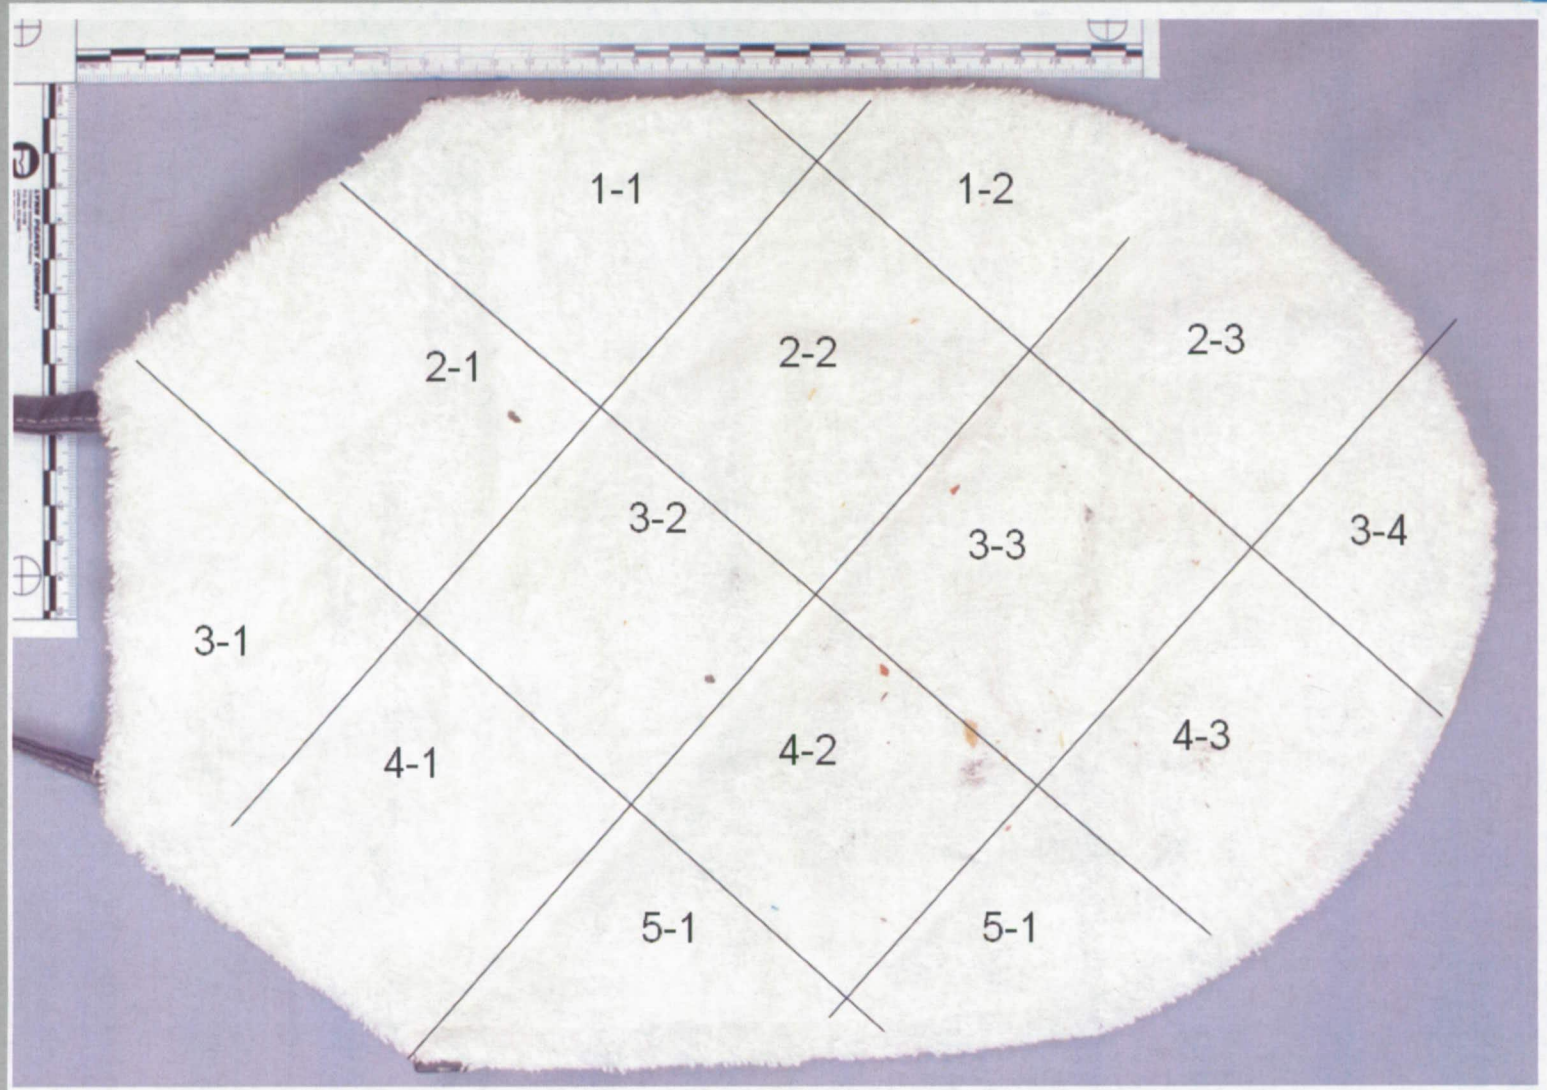
*EVA wipe, multi-ply (part number SED33116397-703)*

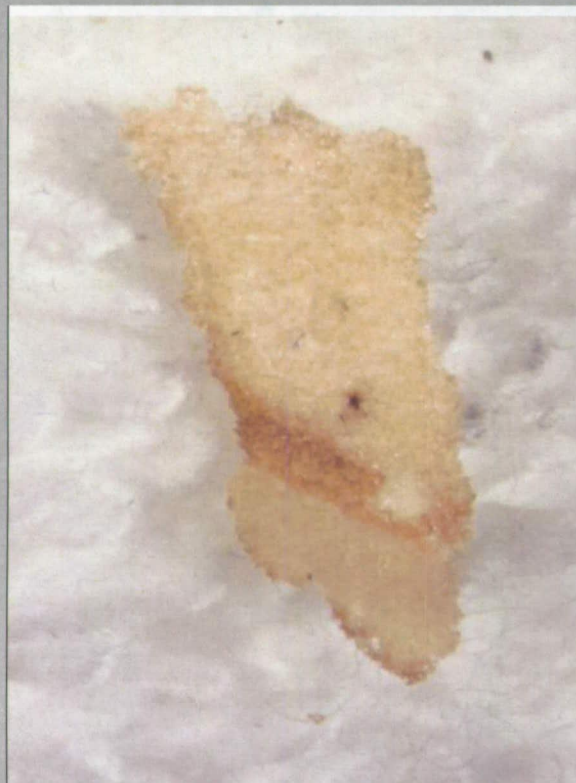
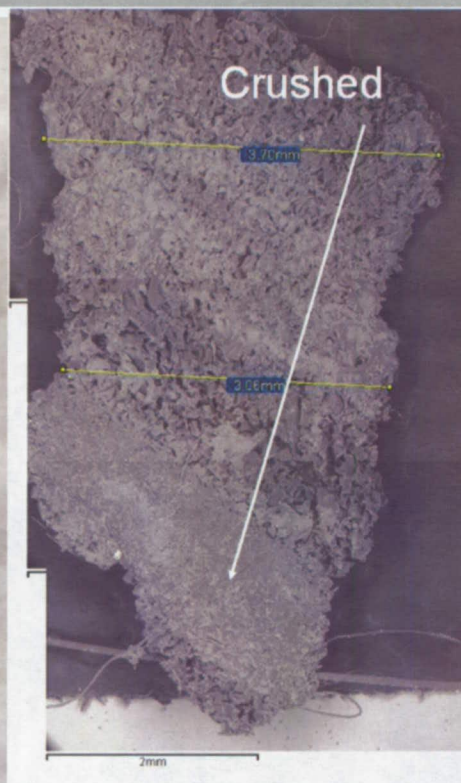
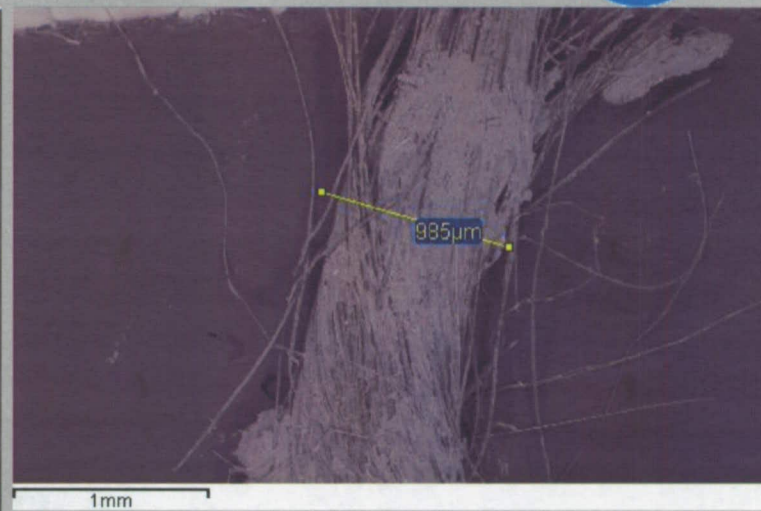
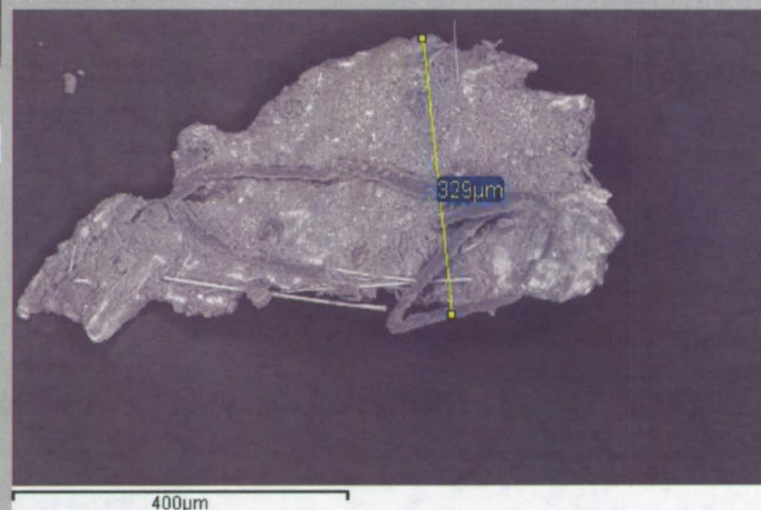
4-2-014

Visual vs SEM four quadrant  
backscatter detector (QBSD)  
images

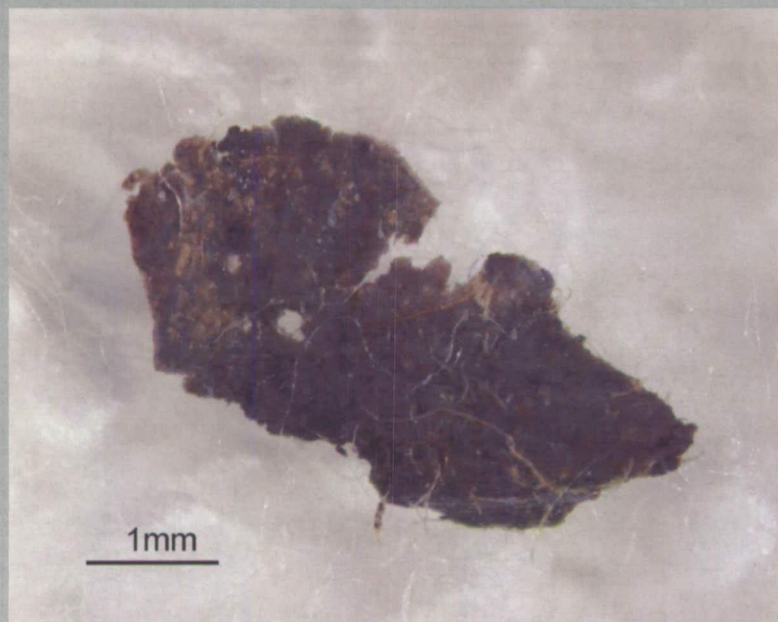
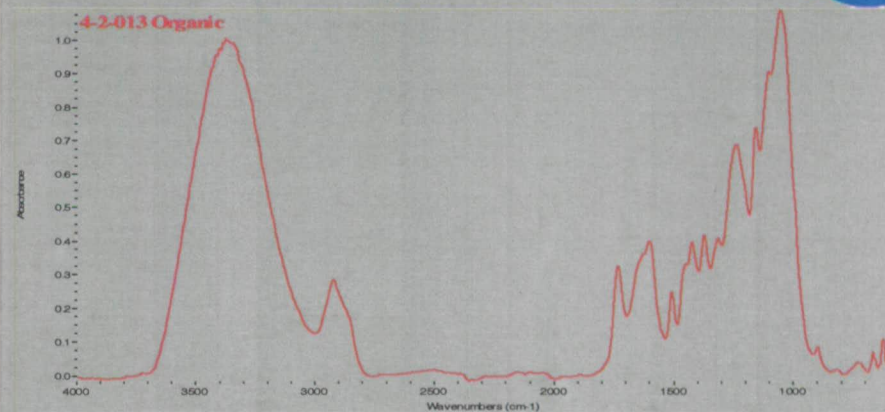
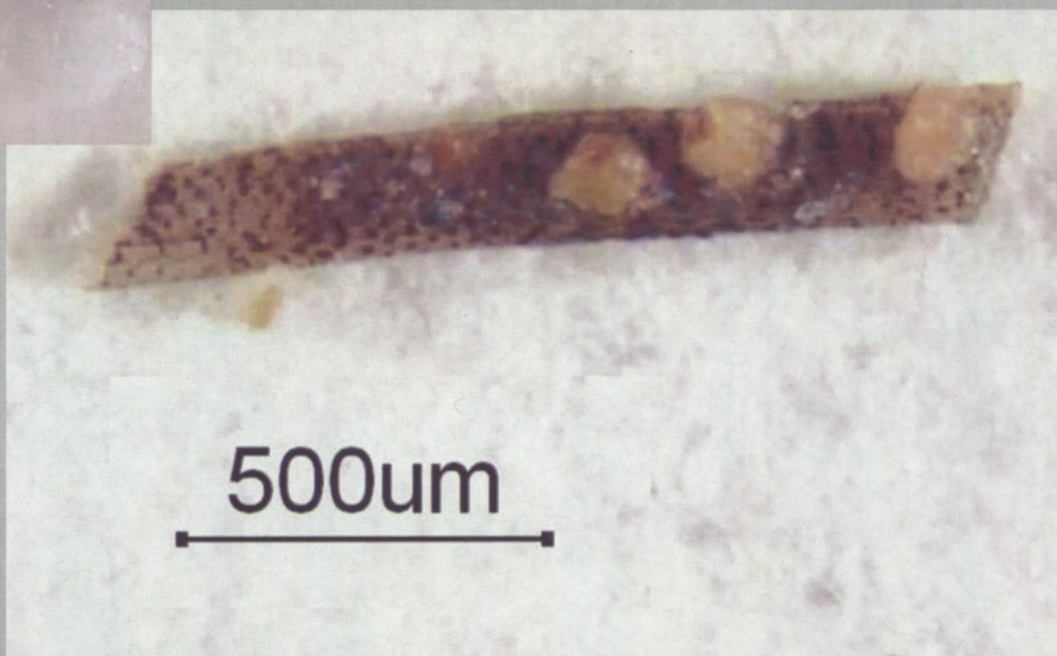
## Biologicals

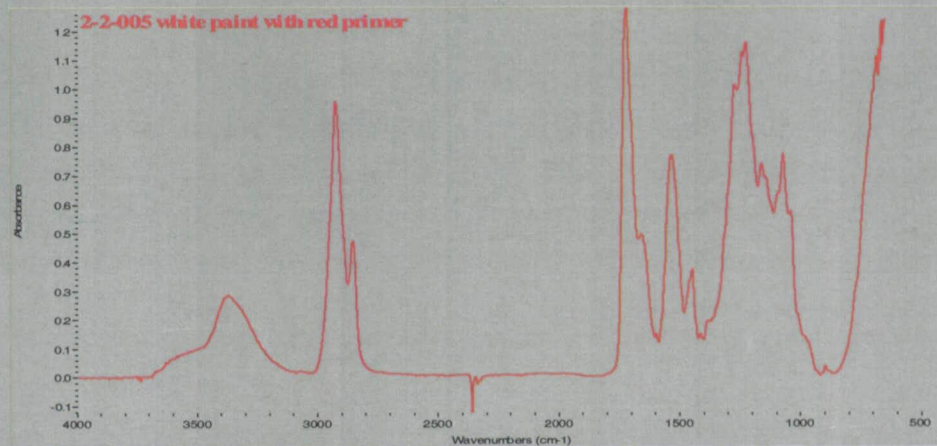
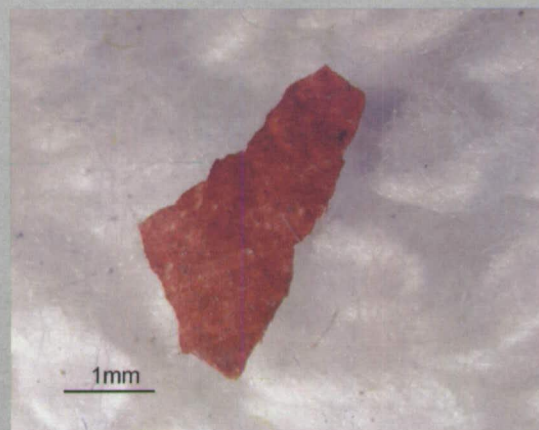
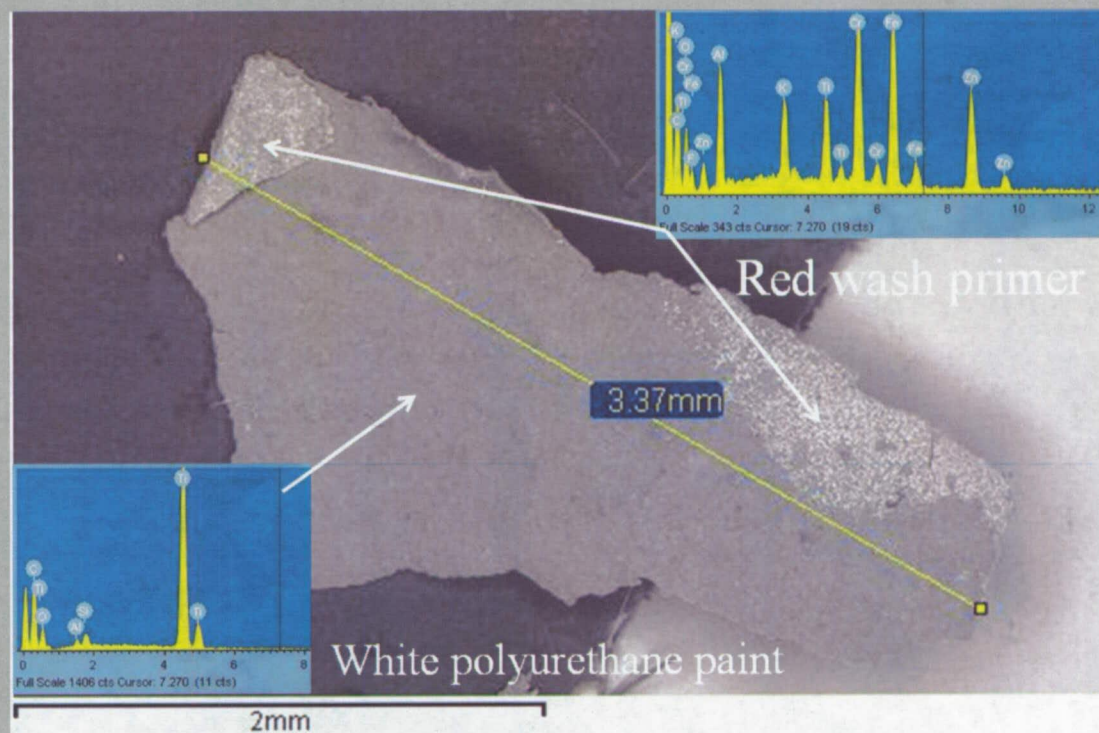
3-3-004

- Color -White coating  
-Red primer
- Layers-two
- Thickness -30  $\mu\text{m}$  coating  
- 8  $\mu\text{m}$  primer
- Resin -Polyurethane
- Inorganic fillers  
Coating Ti, trace Al and Si  
Primer Fe, Zn, Cr, trace Sr

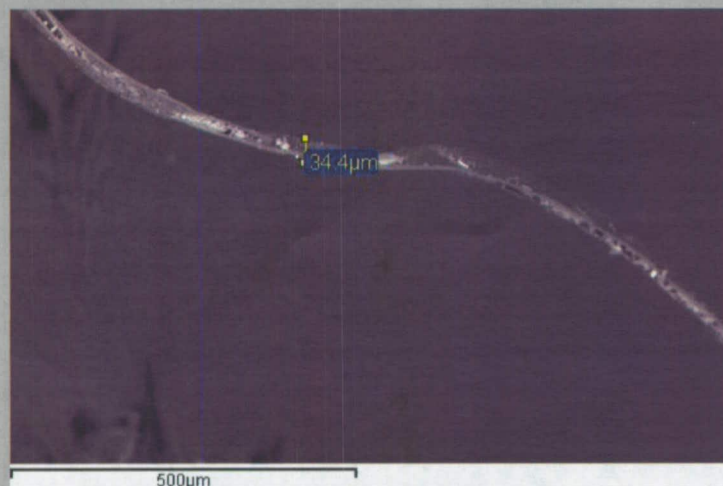
(2-1-001) Cotton fiber

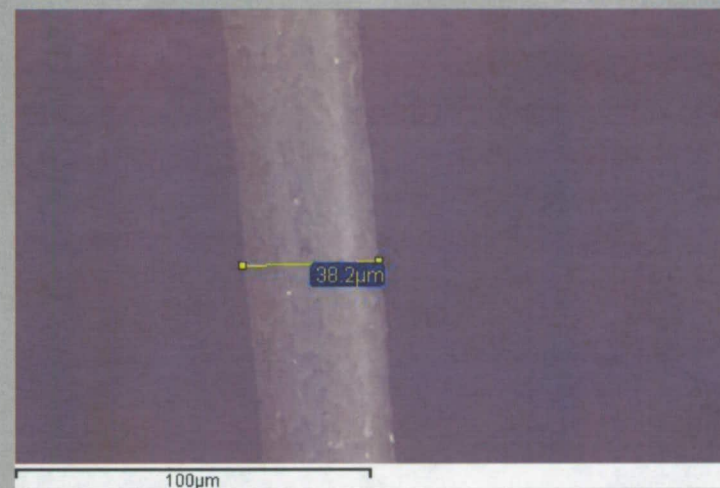
(2-1-004) Hair fiber

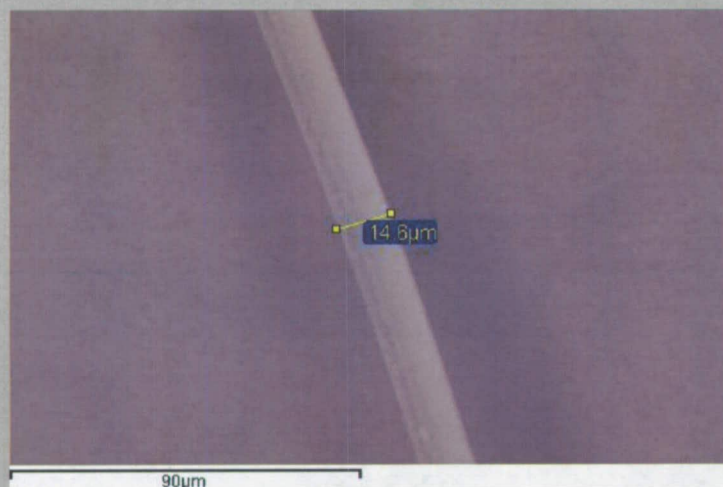
(2-2-004) Synthetic aramid fiber

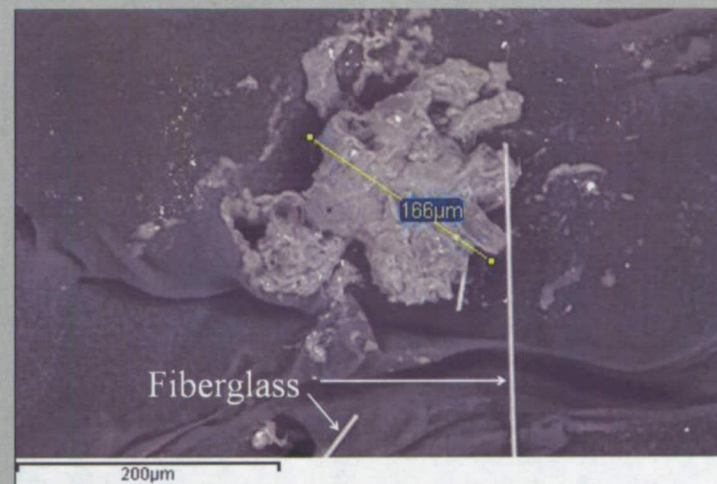
(2-2-008) Fiberglass in grease

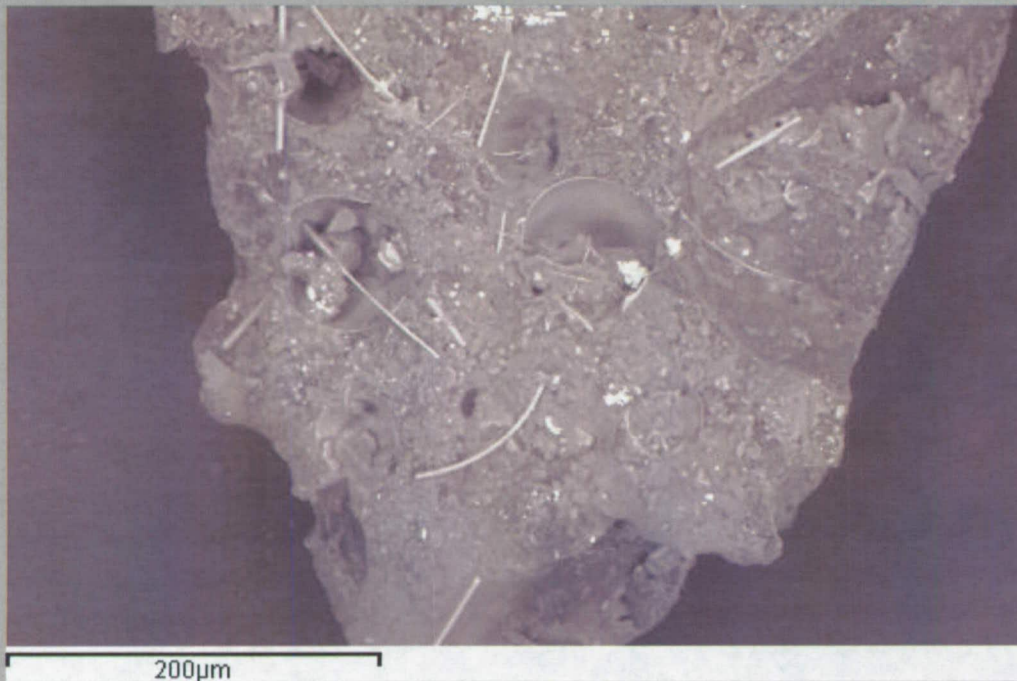
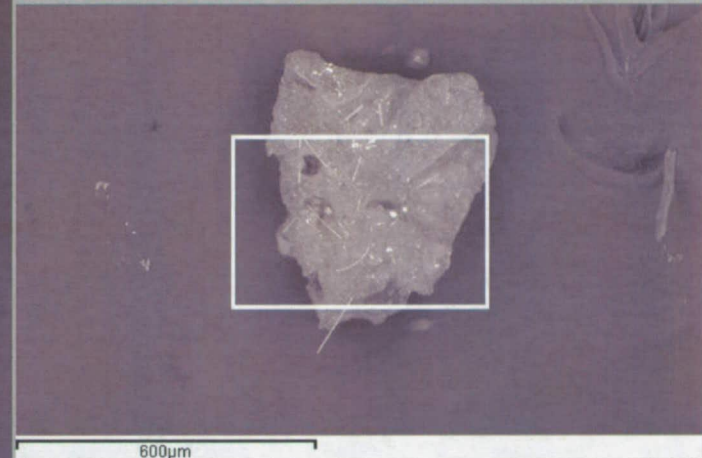
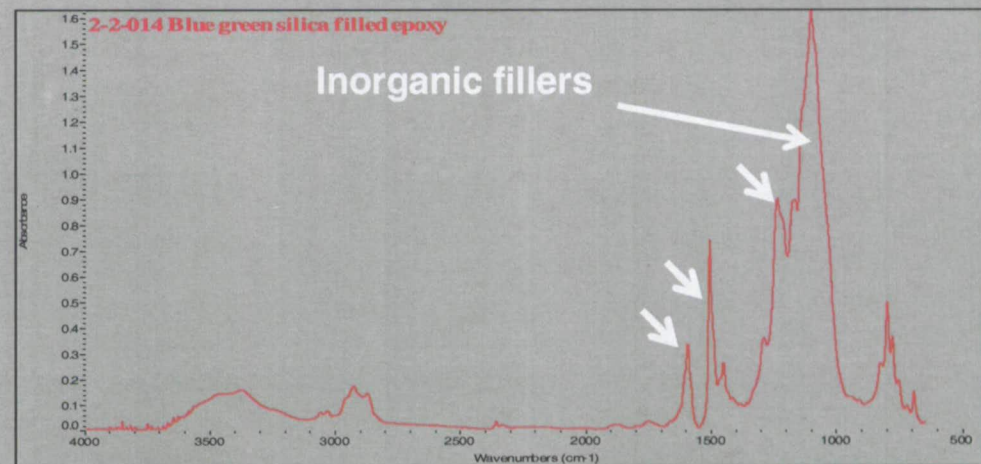
**Blue-green silica filled epoxy found  
on previous samples from MPLM.**

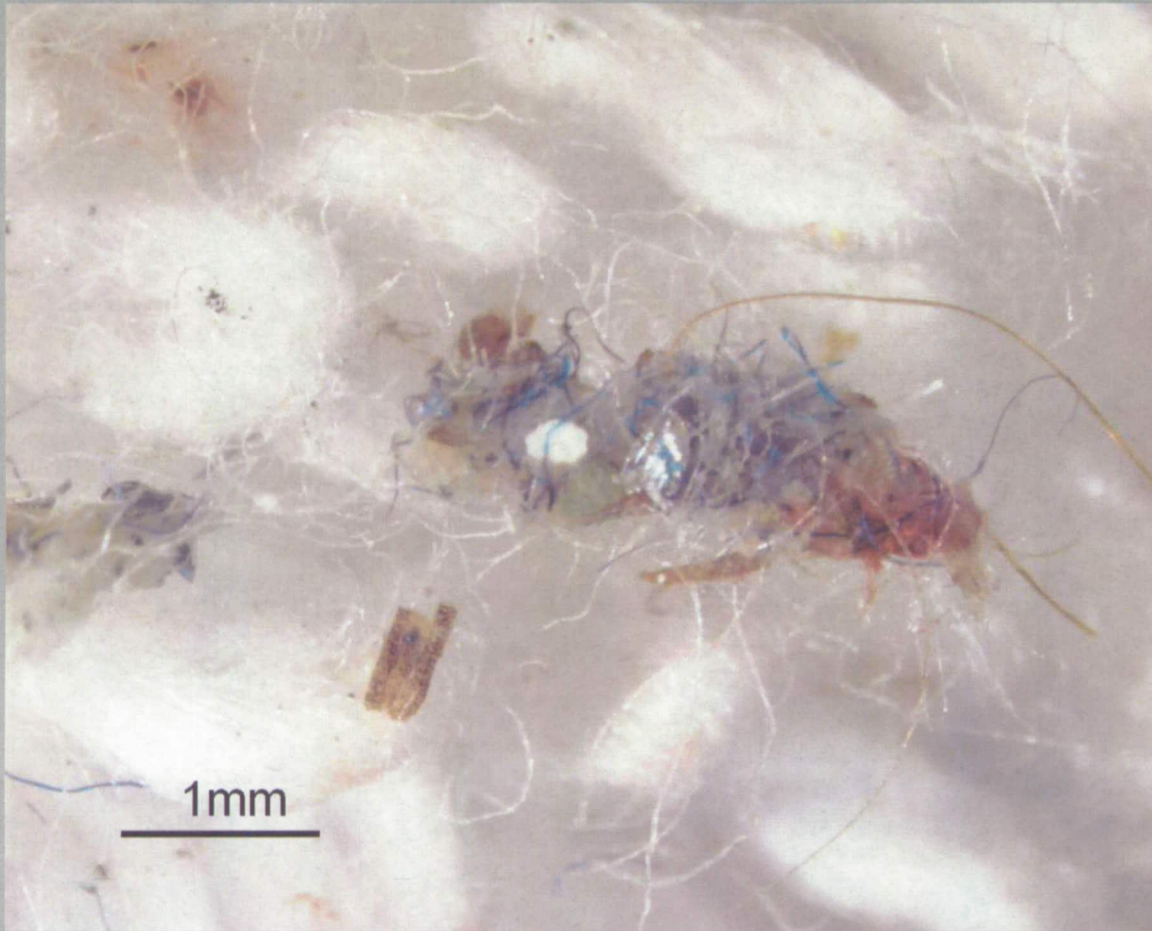
**(2-2-011) Grease with fibers and metals.**

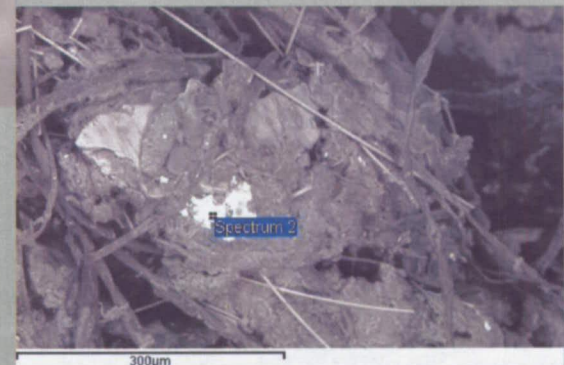
**(4-3-004) Grease with paint, metals, fibers, silicone RTV, biological, etc.**
